after hours leak

How can a facility maintenance provider restore normalcy when leaks occur?

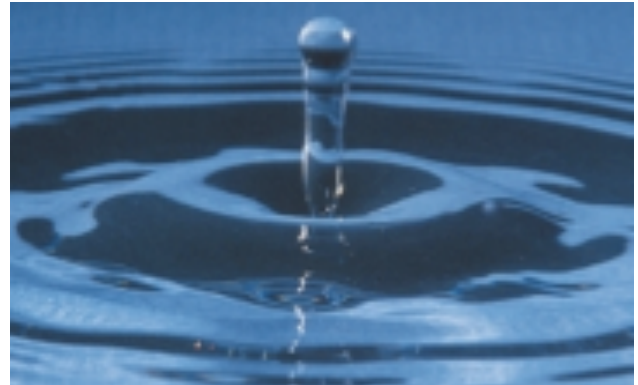
Emergencies always happen at inopportune times. Upon preparing to start their business day, a retail client realized that a heavy after-hours leak originating from an unknown third party store above had occurred during the night, and continued to create damage. Resicom was immediately contacted to handle the emergency assessment.

1. Technicians immediately dispatched to temporarily contain leak with buckets and diverters to prevent further damage to surrounding area. Mess in area is removed and cleaned.
2. Mall operation manager and mall maintenance manager were requested to store to assess leak and determine the source.
3. Technicians traced area through the ceiling to determine leak source and documented area with photos.
4. Technicians questioned tenants above to determine if leaks had been reported or noticed, and to investigate pipe location above client's retail facility. Standing water was discovered in facility above as the opening manager was dispensing with the mess. Although too late to take photos, technicians did secure name of manager and document that water had been present prior to opening of business.
5. Detailed photos were recorded to assist damage assessment and quote preparation.
